Gear Oil Magnetic Filtration Case Study

830E WHEEL MOTOR

Hope Downs MEM

November 2008

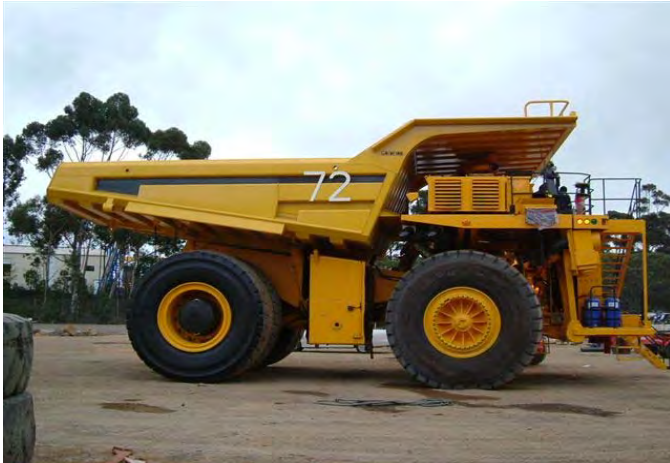
LH Side W/Motor

After 1748hrs the magnetic filters were inspected and the following was found... (see photos LH & RH)
