Magnetic Filtration Case Study  
July 2007

## Unit Rig Haul Truck

### Buckskin Mine Company

Kiewit Mining Group  
Gillette, WY

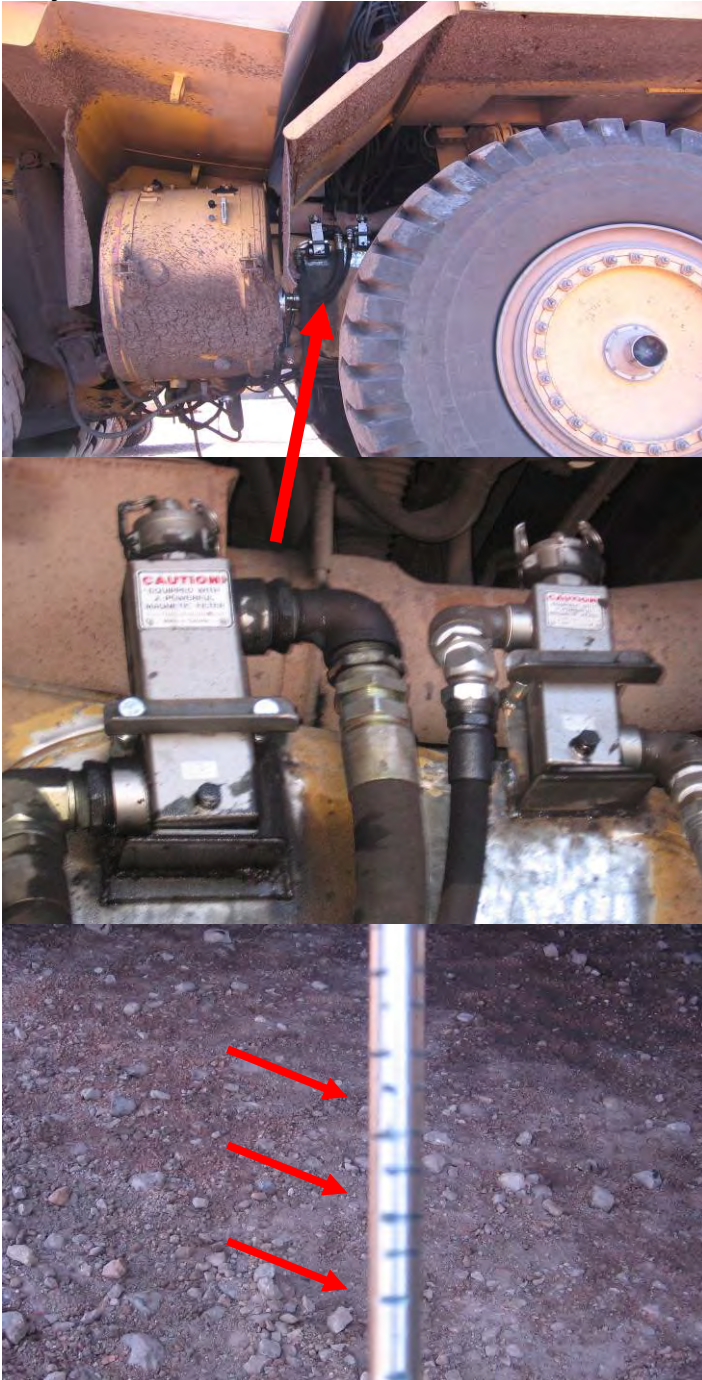
**PROBLEM:** Steering pump failure due to premature wear to hydraulic components.

**RESULTS:** The ferrous metal trapped on the magnetic rod represents approximately 40 hours of running time. If left in the fluid these metal particles will prematurely wear the components and degrade the fluid viscosity. The OEI magnetic filter is easily cleaned and the trapped contamination can be analyzed for component wear identification allowing predictive maintenance planning.

**SOLUTION:** Installation of an OEI 5000 and 4000 Series Scrubbers. The steering and hydraulic systems share the reservoir so the scrubbers were installed on the return lines. The power steering pump and fluids were also changed.
