Case Study: Gear Oil Filtration June 2009

North Parkes Rio Tinto Copper Mine, Australia

APPLICATION: Conveyor Drive Gearbox Flender (B3 SH 15)

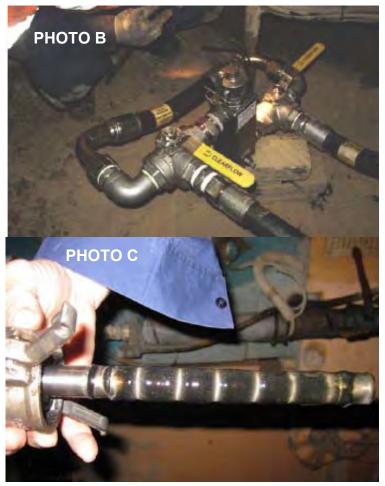
Photo A

PROBLEM: High level of ferrous metal contamination in the gear oil of the main underground haul out conveyor drive gearbox (capacity of 210 L)

SOLUTION: CBC, the Australian distributor for OEI, suggested installing a 4000 series Magnetic Scrubber (4SC49SCL) on the coolant circulation loop with a flow rate of 5 L/min. with a bypass for servicing during operation.
