## Case Study: Drum Rollers

## Interquisa PTA Plant

Montreal, Quebec, Canada

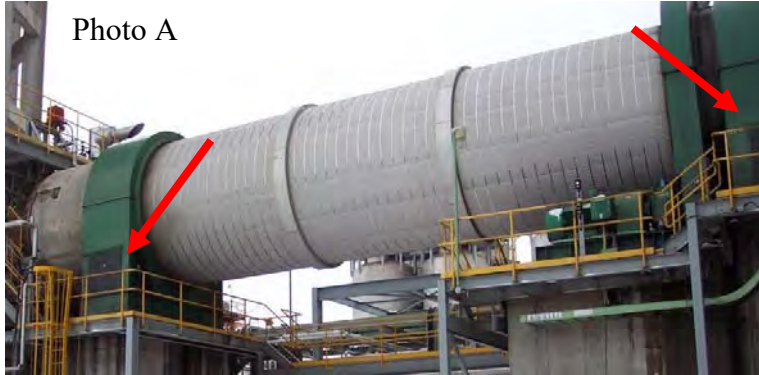
**APPLICATION:** T.A. Dryer (Photo A)

**PROBLEM:** Ferrous metal erosion contamination on the support roller lubrication system. The system does not have a filtration system for the lubrication oil. The contamination causes premature wear of the drums and plugs the oil spray lubrication.

**SOLUTION:** OEI designed a magnetic filter (2R16TH36) with a long handle capable of reaching under the support roller in the oiling tray. This will clean the oil to submicron levels.

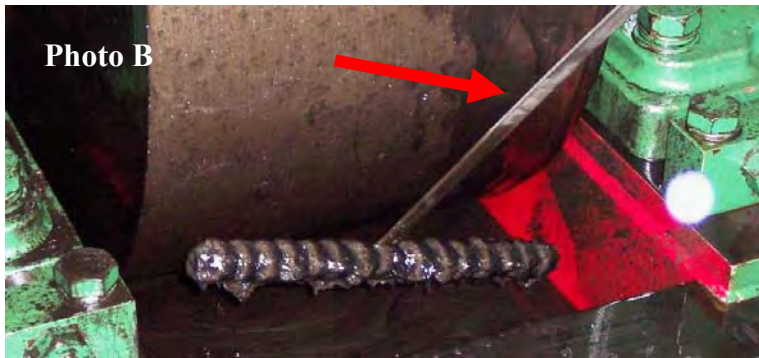
**RESULTS:** This design showed great results as seen by the adjacent photos. Numerous passes were made to remove all the ferrous contaminants, once cleaned the magnetic filter will be left in the oiling tray to continue cleaning. This magnetic filter will extend the life of the oil and drum roller.
