Case Study: Gear Oil Magnetic Filtration

KENNECOTT ENERGY Rio Tinto Mining Group

APPLICATION: Chain Case Oil

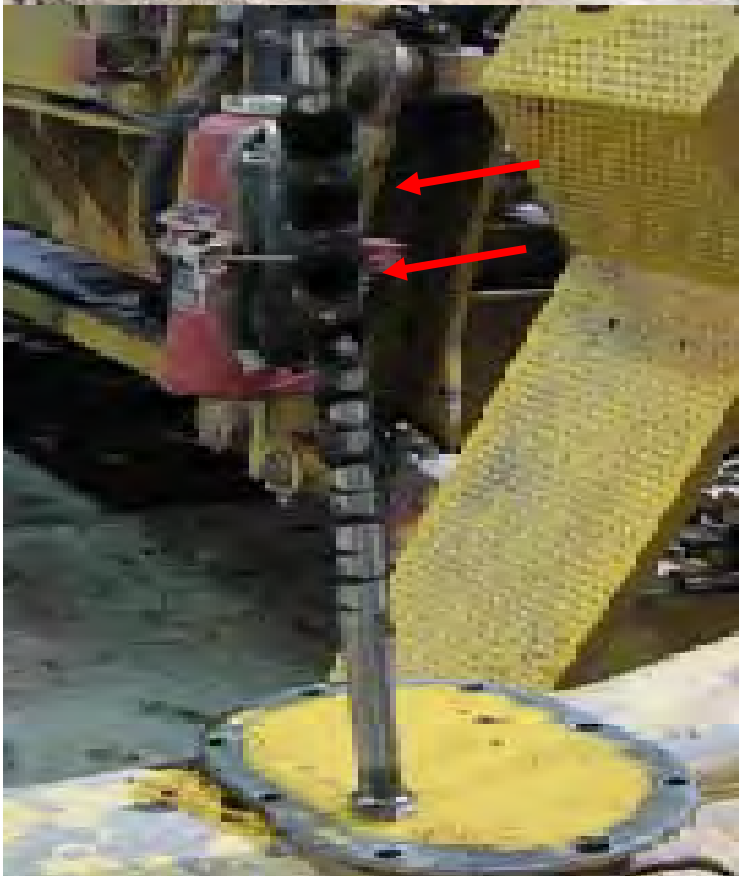
RESULTS: Bob Anderson reported that after 250 hours of operating time a substantial amount of Ferrous Metal was extracted from the chain case oil where there is no filtration thereby reducing wear and extending component and lube oil life.

The photo to the left shows the particles trapped on the OEI magnetic filter. Removal of this contamination from the oil will reduce wear on the chain sprockets, bearings, seals and wet brakes.

SOLUTION: Install an OEI magnetic filter rod (3R24HD78) in the chain case inspection plate. The magnetic filter is located in the central splash area for maximum filtration and does not interfere with the operation.
