## Magnetic Filtration Case Study

## Syncrude

### Oil Sands Open Pit Mine

**APPLICATION:** 793B Transmission

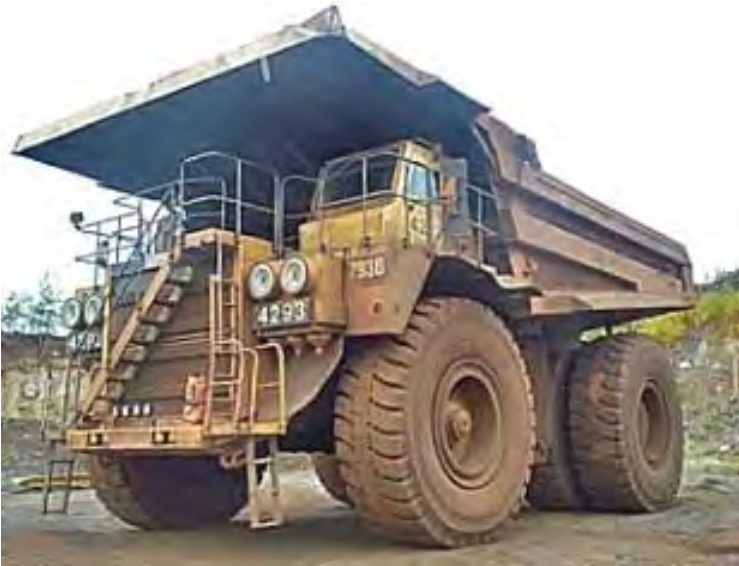
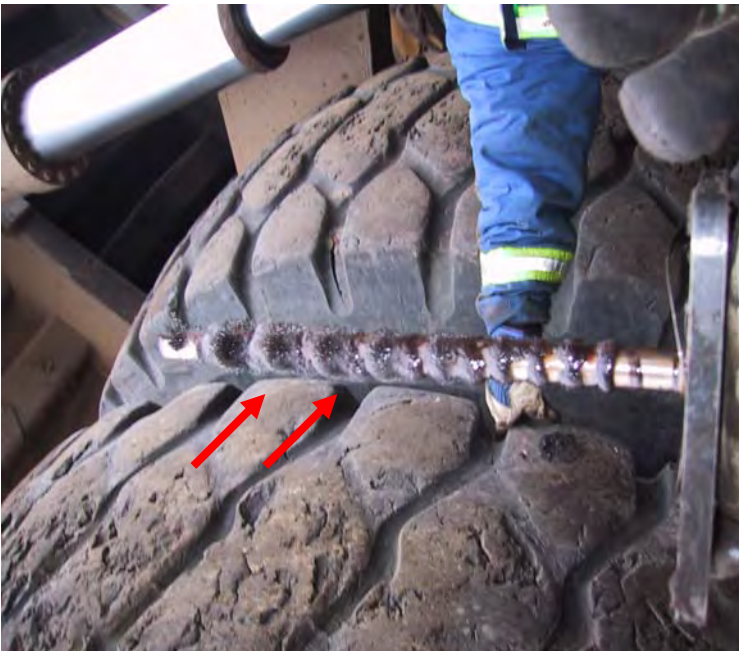
**RESULTS:** After 500 hours, a substantial amount of Ferrous Metal was extracted and trapped on the OEI magnetic filter. If left in the fluid these metal particles will prematurely wear the transmission components and degrade the fluid viscosity.

The OEI magnetic filter is easily cleaned and the trapped contamination analyzed for component wear identification allowing predictive maintenance planning. For further information contact our office or visit our website [www.OneEyeIndustries.com](http://www.OneEyeIndustries.com).
