Case Study: Gear Oil Magnetic Filtration

Bucyrus Erie 49R III Rotary Drill Kennecott Utah Copper Magna, Utah

APPLICATION: Rotary Gear Case Filtration

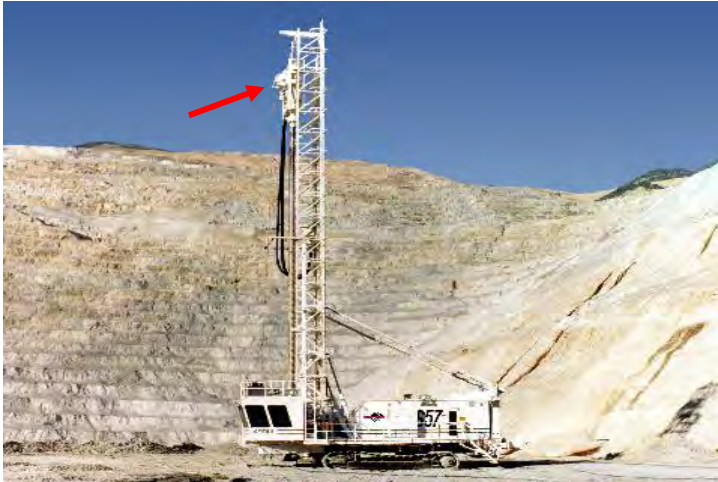
Photo A

PROBLEM: No filtration and increasing levels of ferrous contamination (oil analysis) suspended in the oil. When the gear oil is replaced the fine metal contamination adheres to the gears and walls of the gear case.

RESULTS: (Photo's A & B) After 3 weeks of operation the magnetic filter was removed and a significant amount of ferrous metal was trapped on the magnetic filter rod. This contamination is filtered from the oil down to submicron levels thereby reducing premature wear, extending the oil life planning and the gear box component life. This will result in increased operational time improving production.

SOLUTION: Installation of an OEI Magnetic Filter (2RNPT112ES) in the optimum splash area of the rotary gear case.
