Magnetic Filtration Case Study

P&H 2800XP Shovel

Rio Tinto Energy America

APPLICATION: Crowd Gearbox on P&H 2800XP Shovel

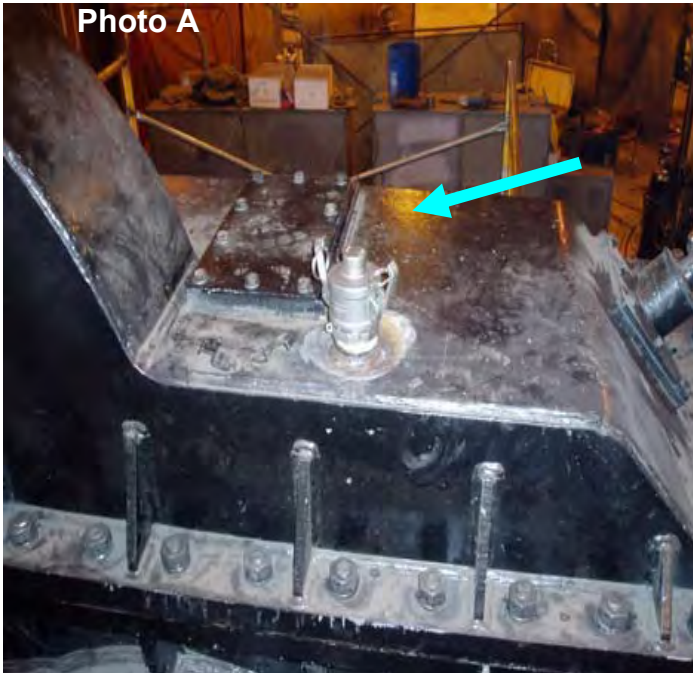
SOLUTION: Mr. Simunek suggested the installation of an OEI Magnet Filter rod (3RCL18) in Crowd gearbox during rebuild. (Photo A)

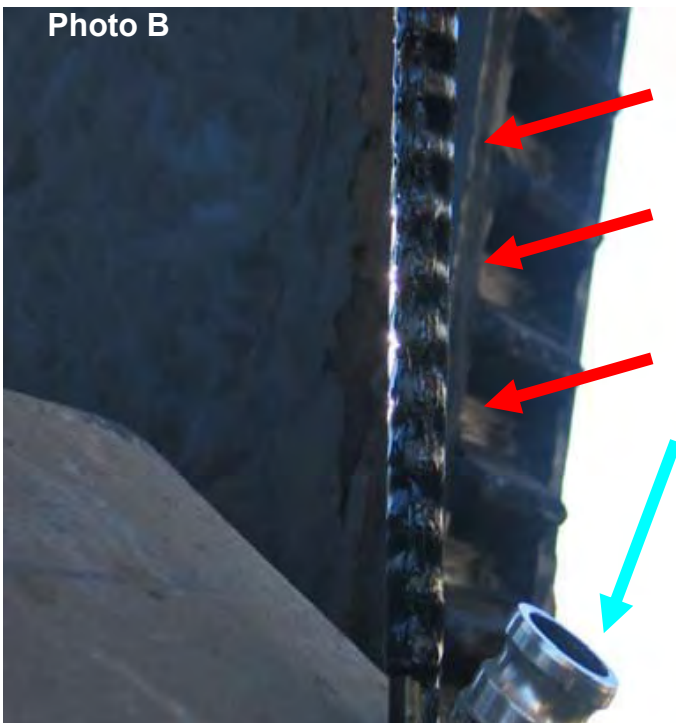
RESULTS: The ferrous metal trapped on the magnetic filter (Photo B) represents approximately 800 hours of running time. If left in the fluid these metal particles will prematurely wear the components and degrade the fluid viscosity.

The OEI magnetic filter is easily cleaned and the trapped contamination can be analyzed for component wear identification allowing predictive maintenance planning.
