Magnetic Filtration Case Study May 2008

Newcrest Mining Ltd Cracow Gold Mine Australia

APPLICATION: Symons 4 ¼' Cone Crusher

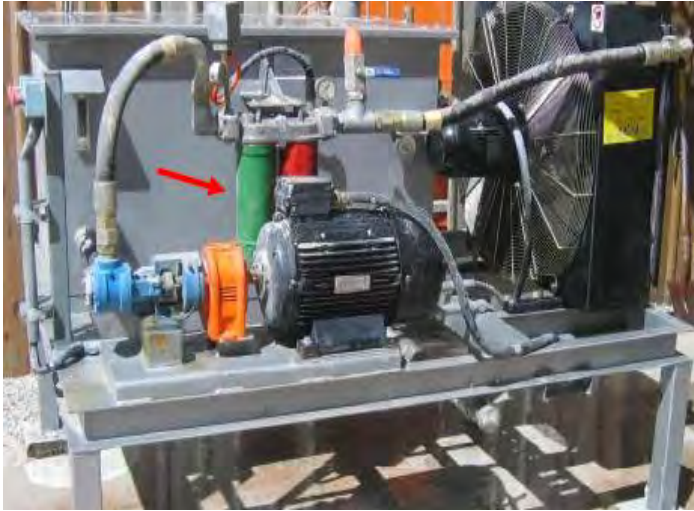
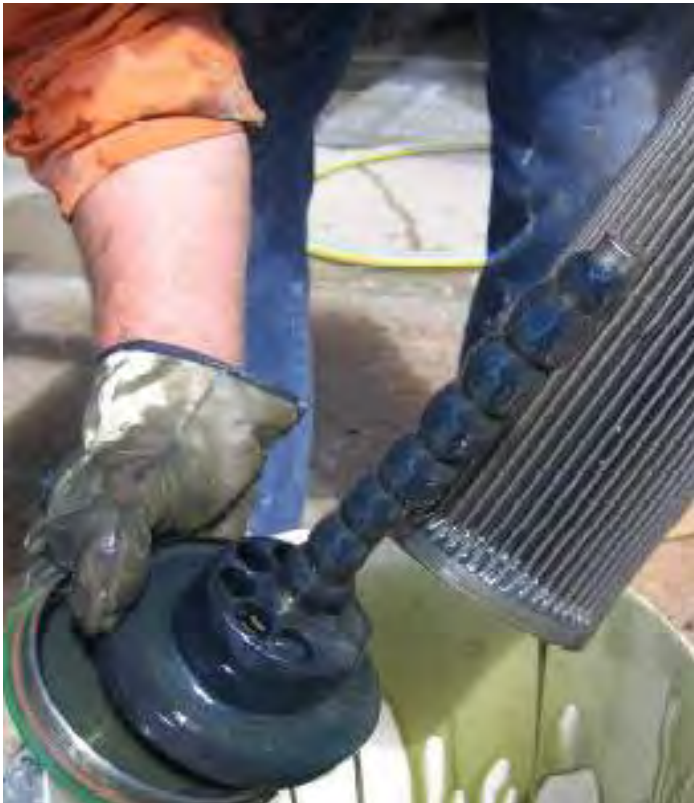
RESULTS: After 64 hours, a substantial amount of Ferrous Metal was extracted and trapped on the OEI magnetic filter. If left in the fluid, these metal particles will prematurely wear the components and degrade the fluid viscosity.

Conclusion: Newcrest's view is that without the One Eye filter a proportion of this material would have found its way back to the bearings, gears and lubrication pump. This could have led to premature failures and costly unplanned maintenance.

The OEI magnetic filter is easily cleaned and the trapped contamination can be analyzed for component wear identification allowing predictive maintenance planning. For further information contact our office or visit our website www.OneEyeIndustries.com.
