## CASE STUDY

RIO TINTO IRON ORE GROUP

HOPE DOWNS, AUSTRALIA / NOV 2008

CAT 16H GRADER CHAIN CASE

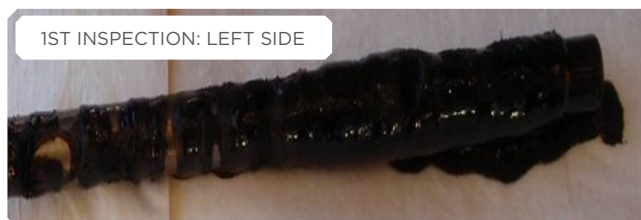
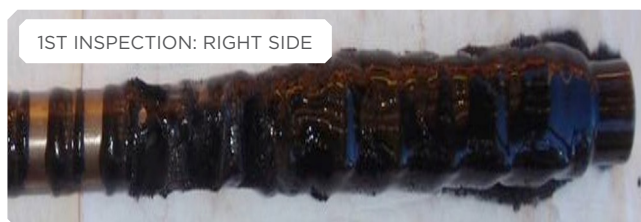
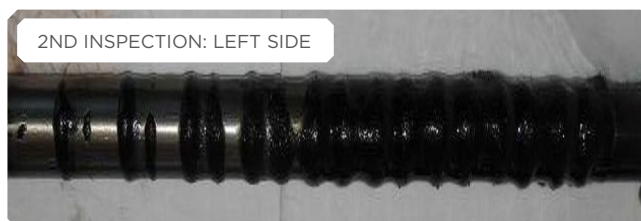
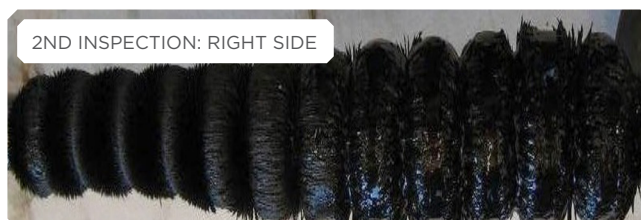
The first inspection showed significant wear debris resulting from the operation of the chain, sprocket and gear. The second inspection 60 days later, with oil analysis, identified a reduction of the metal contamination on the LH side, and a considerable increase in ferrous debris on the RH side tandem (on grader 12D1).

To further confirm the analysis results to personnel that doubted them, the magnetic filter elements were pulled again from both sides. The LH side had a reduced amount of debris which confirmed the oil analysis. The RH magnetic filter element showed a huge amount of ferrous debris on the magnetic filter element, so much so that the maintenance manager was only just able to get it out of the 2 1/2" opening. The RH side tandem was stripped and the brake packs were overhauled. The RH side was in such bad condition that it is very likely the brakes were ineffective on that side. The friction discs were cracked and warped and the internal gear/splined portion of the brake pack casing where the friction disc's are retained were completely stripped. The magnetic filter element, utilized as a preventative maintenance tool, prevented serious injury due to worn out breaks.

Install an OEI magnetic filter on the chain case inspection plate. This design sets the magnetic filter in the central splash area for maximum filtration without interfering with system operation.
