Gear Oil Magnetic Filtration Case Study

830E WHEEL MOTOR

Hope Downs MEM

November 2008

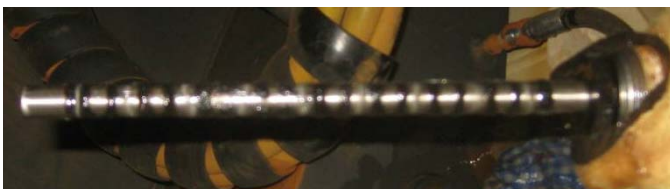
LH Side W/Motor

RESULTS: The trends for Fe show a significant drop after the installation of the OEI Magnetic Filter from 105ppm to 20ppm and 85ppm to 20ppm. As of the last sample taken, both sumps are now at 5ppm Fe.

After 1748hrs the magnetic filters were inspected and the following was found... (see photos LH & RH)

SOLUTION: Installation of OEI Magnetic Filters (2RNPT1149ES) in place of the manufacturers' magnetic drain plugs in the wheel motor sumps.
