### **Case Study**

Cat Haul Truck Gearboxes Mainland Sand and Gravel Abbotsford BC, 2010-2014

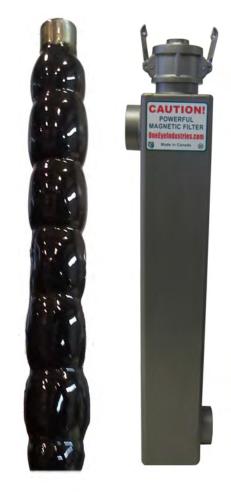
В

**RESULTS:** The magnetic filters removed a large amount of both ferrous (8.82%) and non-ferrous (91.18%- with the majority being Calcium) contamination over a six hour loop time resulting in a decrease in ISO to 21/9, see Photo B and analysis (Page 2). The majority of this was below ten microns to sub-micron in size and would have travelled right through the traditional filter element.

**SOLUTION:** Wes Lindemere of AIT in Grande Prairie, suggested the installation of OEI's two 24" magnetic filters (Scrubbers) as the primary filter on the kidney loop before the traditional Donaldson filter as well as an OEI magnetic y-strainer as a final filter before returning the oil to the differential, with a target of cleaning the oil to a lower than ISO clean oil standard(16/13).
