## Case Study: Gear Oil Magnetic Filtration

### 830E WHEEL MOTORS GE's AC DRIVE SYSTEM

**KENNECOTT ENERGY  
RIO TINTO MINING CORP.**  
Gillette, Wyoming, USA

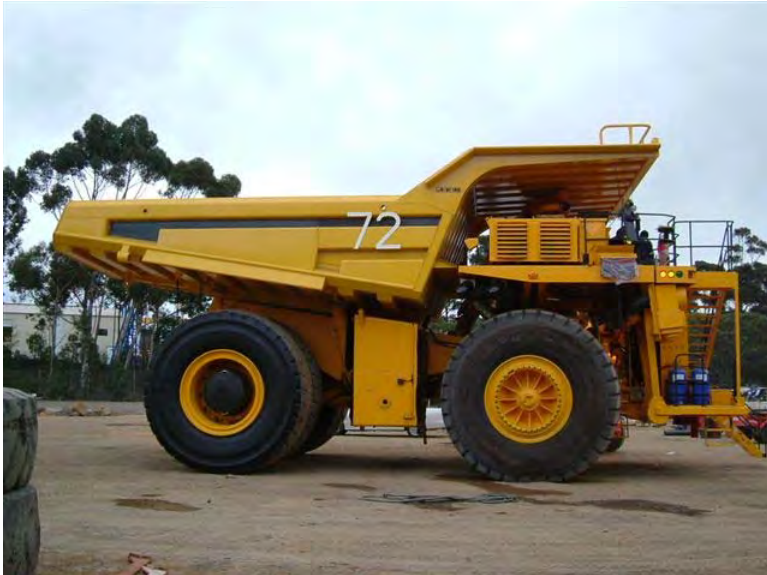
**SOLUTION:** Bob Anderson of Rio Tinto has installed two OEI Magnetic Filters (2RNPT1149ES) in the wheel drive reservoir.

**RESULTS:** After 500 hours of operating time on the 830E, the magnetic filters installed to protect the wheel motors were removed with an ample amount of ferrous metal.

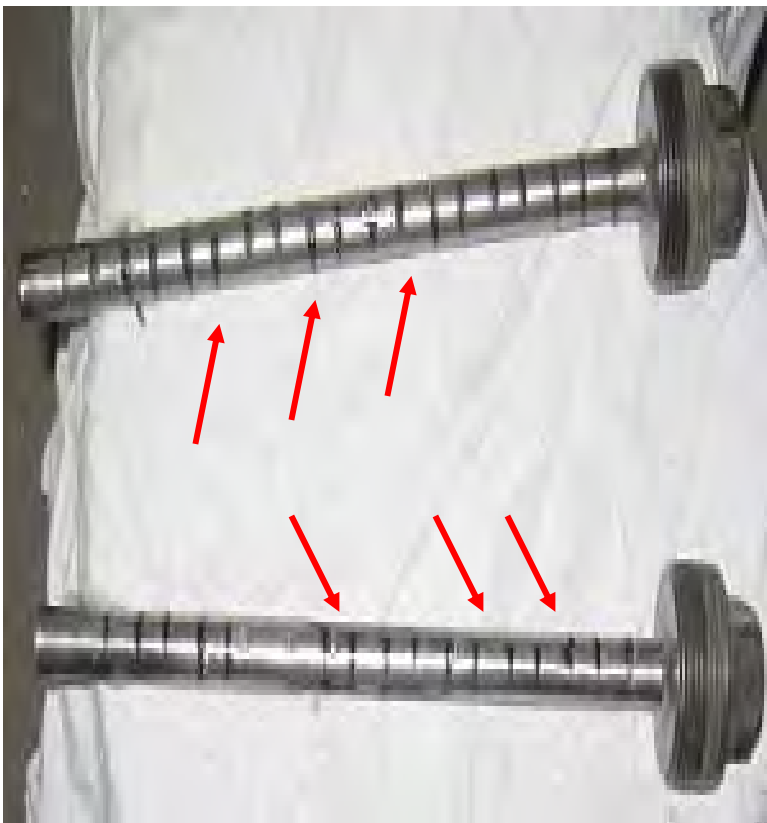
**"The iron counts in both did show a drop."** With the removal of the ferrous metal it is reasonable to state that the wear cycle will be reduced and the gear oil life will be extended.
