## Magnetic Filtration Case Study

## BHP, Billiton Mitsubishi Alliance Blackwater Mine

**APPLICATION:** 789B Haul Truck TKD6088  
Coolant System

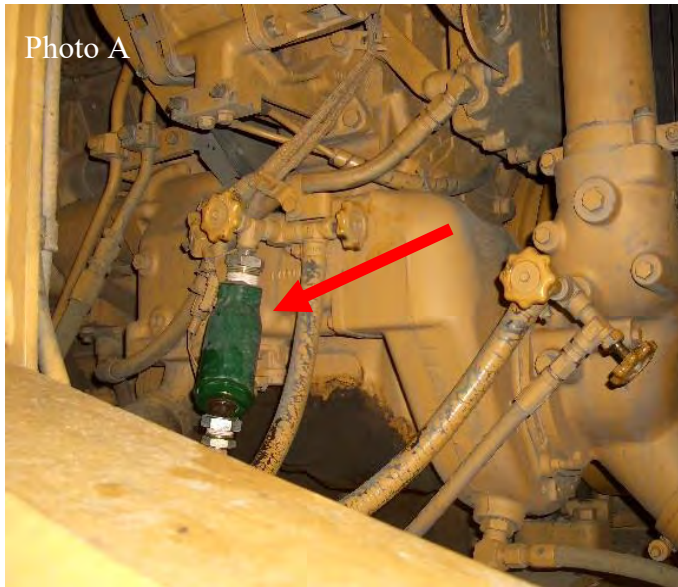
**SOLUTION:** Installation of OEI Magnetic Y-  
Strainer (5YB1TX) on secondary coolant line  
(see Photo A)

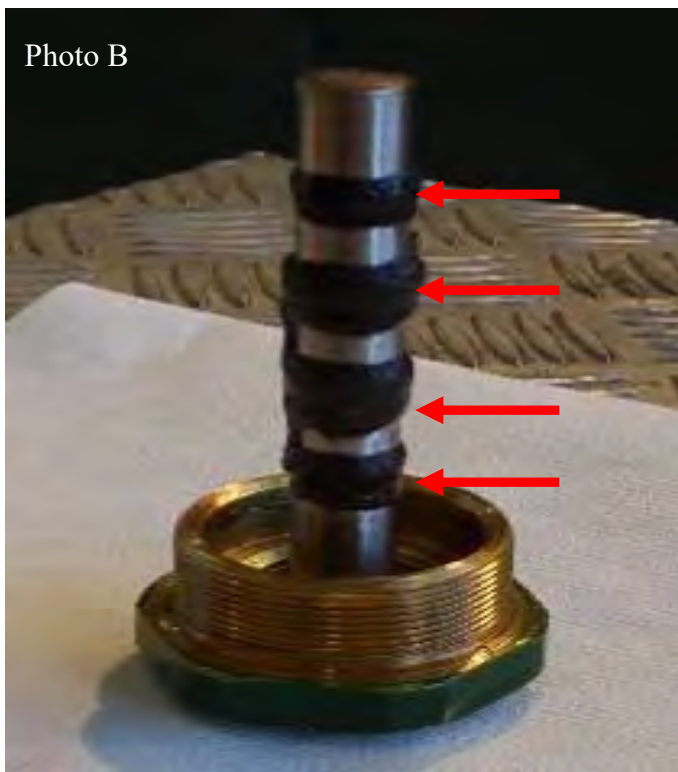
**RESULTS:** After 500 hours of engine operation,  
the OEI magnetic filter was removed revealing a  
substantial amount of ferrous metal that had  
been extracted from the coolant fluid (see Photo  
B). If left circulating in the coolant fluid, these  
metal particles will prematurely wear out cooling  
system components such as the water pump,  
radiator and seals in addition to degrading the  
fluid.

The OEI magnetic filter is easily cleaned  
enabling analysis of trapped contamination for  
component wear identification and aiding in  
predictive maintenance planning. For further  
information contact our office or visit our website  
[www.OneEyeIndustries.com](http://www.OneEyeIndustries.com).
