Gear Oil Magnetic Filtration Case Study

Mining Company
Eastern Australia
Hail Creek, Queensland
May 2008

APPLICATION: Komatsu 475 Dozers
Final Drives

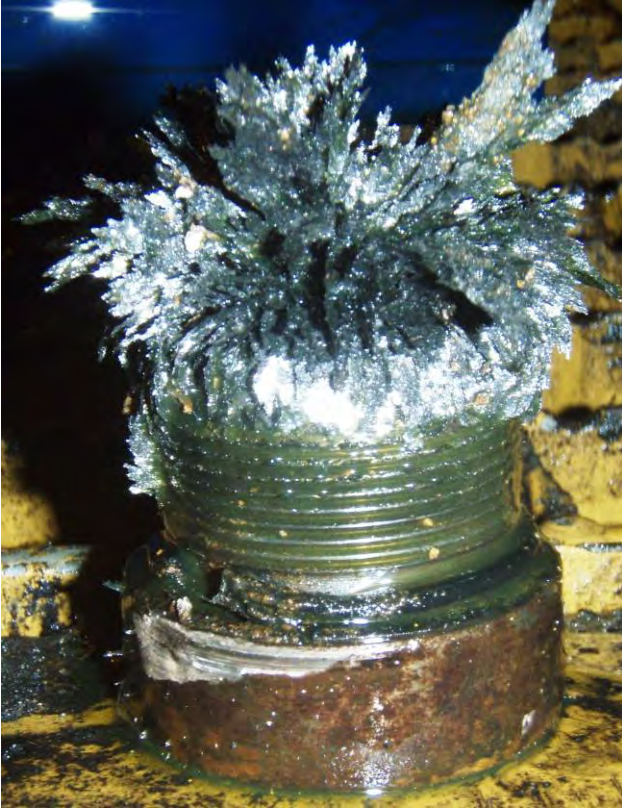
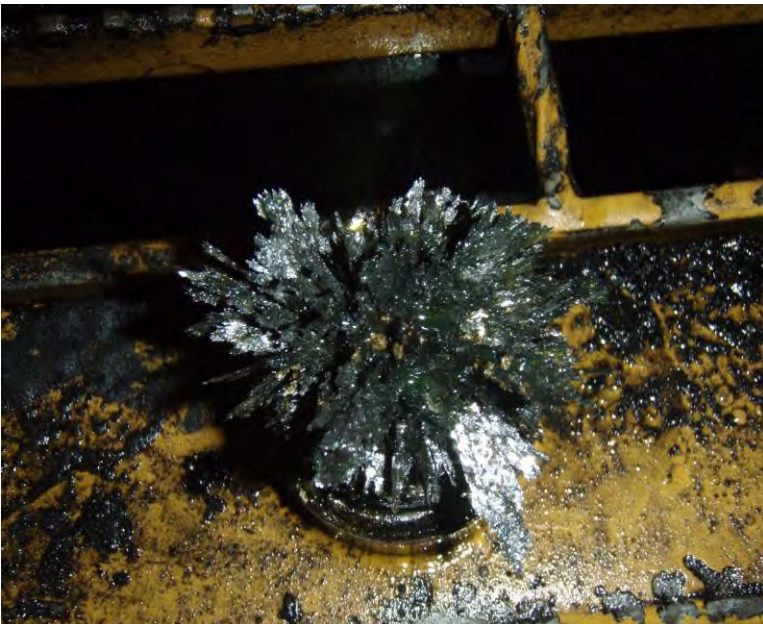
PROBLEM: High metal counts, brought on with a change of lubricant that was not compatible with the final drives.

RESULTS: The Final Drives were fitted with One Eye magnetic plugs as they did not have spares and they needed the Dozer to keep going until the spares arrived. This is the results after 11,420 hrs.

SOLUTION: Replace OEM ceramic magnetic filter plugs with OEI Magnetic Filter plugs.

As a result they are now installing One Eye Magnetic Plugs in both the Komatsu and Caterpillar equipment. They are also implementing an analysis program for these plugs. Purchasing an extra plug for each location when the plug is removed it is package and sent for testing and the second plug is installed. This procedure will eliminate any chance of cross contamination.
